# Rector Creek Reservoir Watershed Sanitary Survey 2009 Update

July 10, 2009

Ridge to River Incorporated Environmental Services

Veterans Home of California and Rector Reservoir Surface Water Treatment Facility

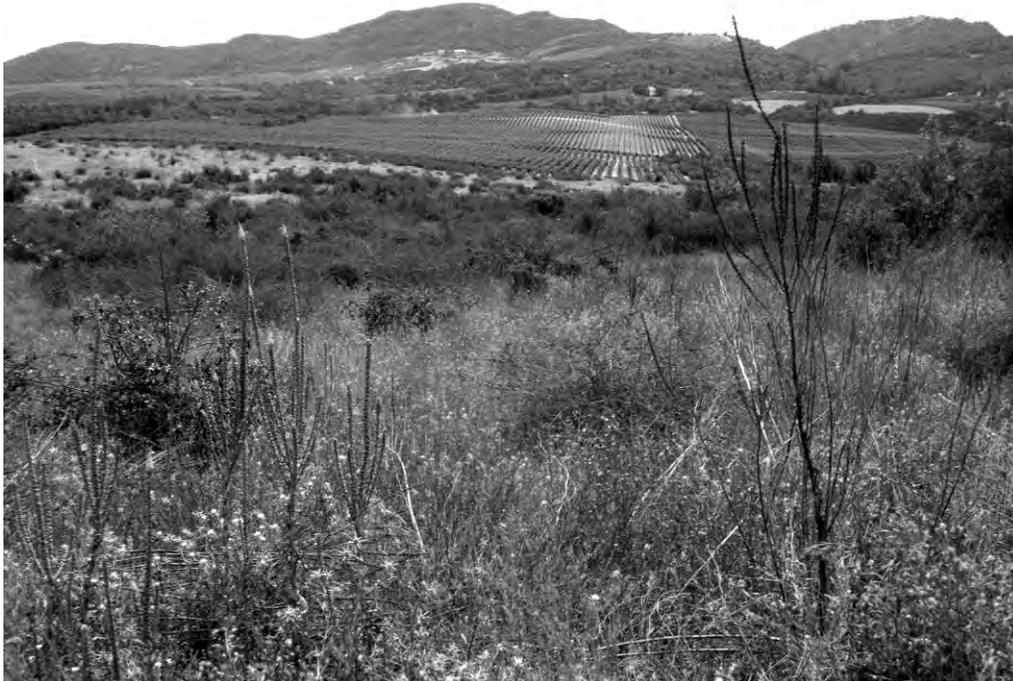
Figure 2: Rector Creek Watershed Topography from USGS contours with roads, streams, watershed boundary

The Rector Creek Watershed is steeply mountainous around the reservoir. Steep bedrock gorges at stream inlets give way to a relatively flat mesa in the upper elevations of the watershed (Figures 2, 3, 4). Vegetation is dominated by chaparral, dense stands of hardwoods, and grasslands. From the dam and throughout the reservoir area, the upper mesa cannot be observed do to the steep terrain around the reservoir, and likewise, the lower gorge and reservoir cannot be observed from most of the flat mesa at the top. The upper mesa has been in a developmental phase since the early 1990's.

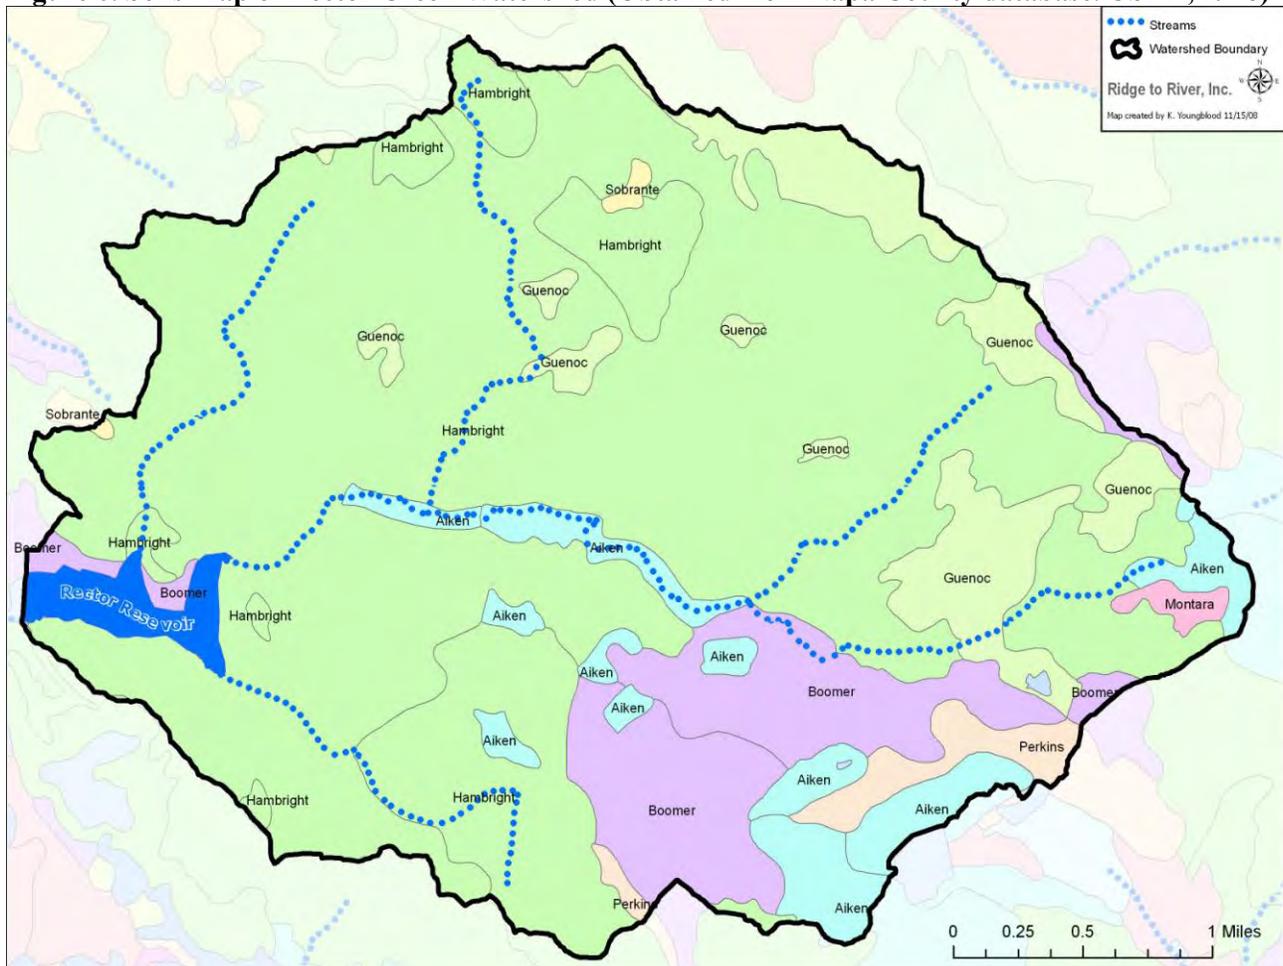
**Figure 6. Soils Map of Rector Creek Watershed (Obtained from Napa County database. USDA, 1978)**

The soils found in the Rector Reservoir Watershed are listed below. These soil types are keyed to numbered polygons in Figure 6. The rocky Hambright complex, 50 to 75 percent slopes: makes up the majority of the Rector Watershed. This soil is approximately 25% gravel, 20% sand, 25% silt, and 30% clay (as sited in EIR. Ellen Wentworth 1995; USDA NRCS 1978; PPI Engineering, 1996).

The hazard of erosion in Rector Watershed ranges from slight to high. Soils within the steeper portions of the watershed areas are unstable due to weathering and steep slopes beyond the angle of repose prone to erosion, landslides, and slumping. The dominant Hambright soil complex has both low infiltration and slight to moderate erosion hazard. This low potential for erosion is likely partially due to their buffering with coarse rock fragments on their surface (Poesen, et al. 1994; Cerda, 2001; Descroix et al., 2001; Ballanay and Grismer, 2005). Other than minor concentrations of serpentine some watershed soils, we know of no other soil mineral deposit that could pose a hazard to the water quality in Rector Reservoir. Mining has not been active in the present or past in this watershed (NCPD).

**Table 2. Soil Type Keys for Soils Mapped in Rector Reservoir Watershed, in Figure 6**

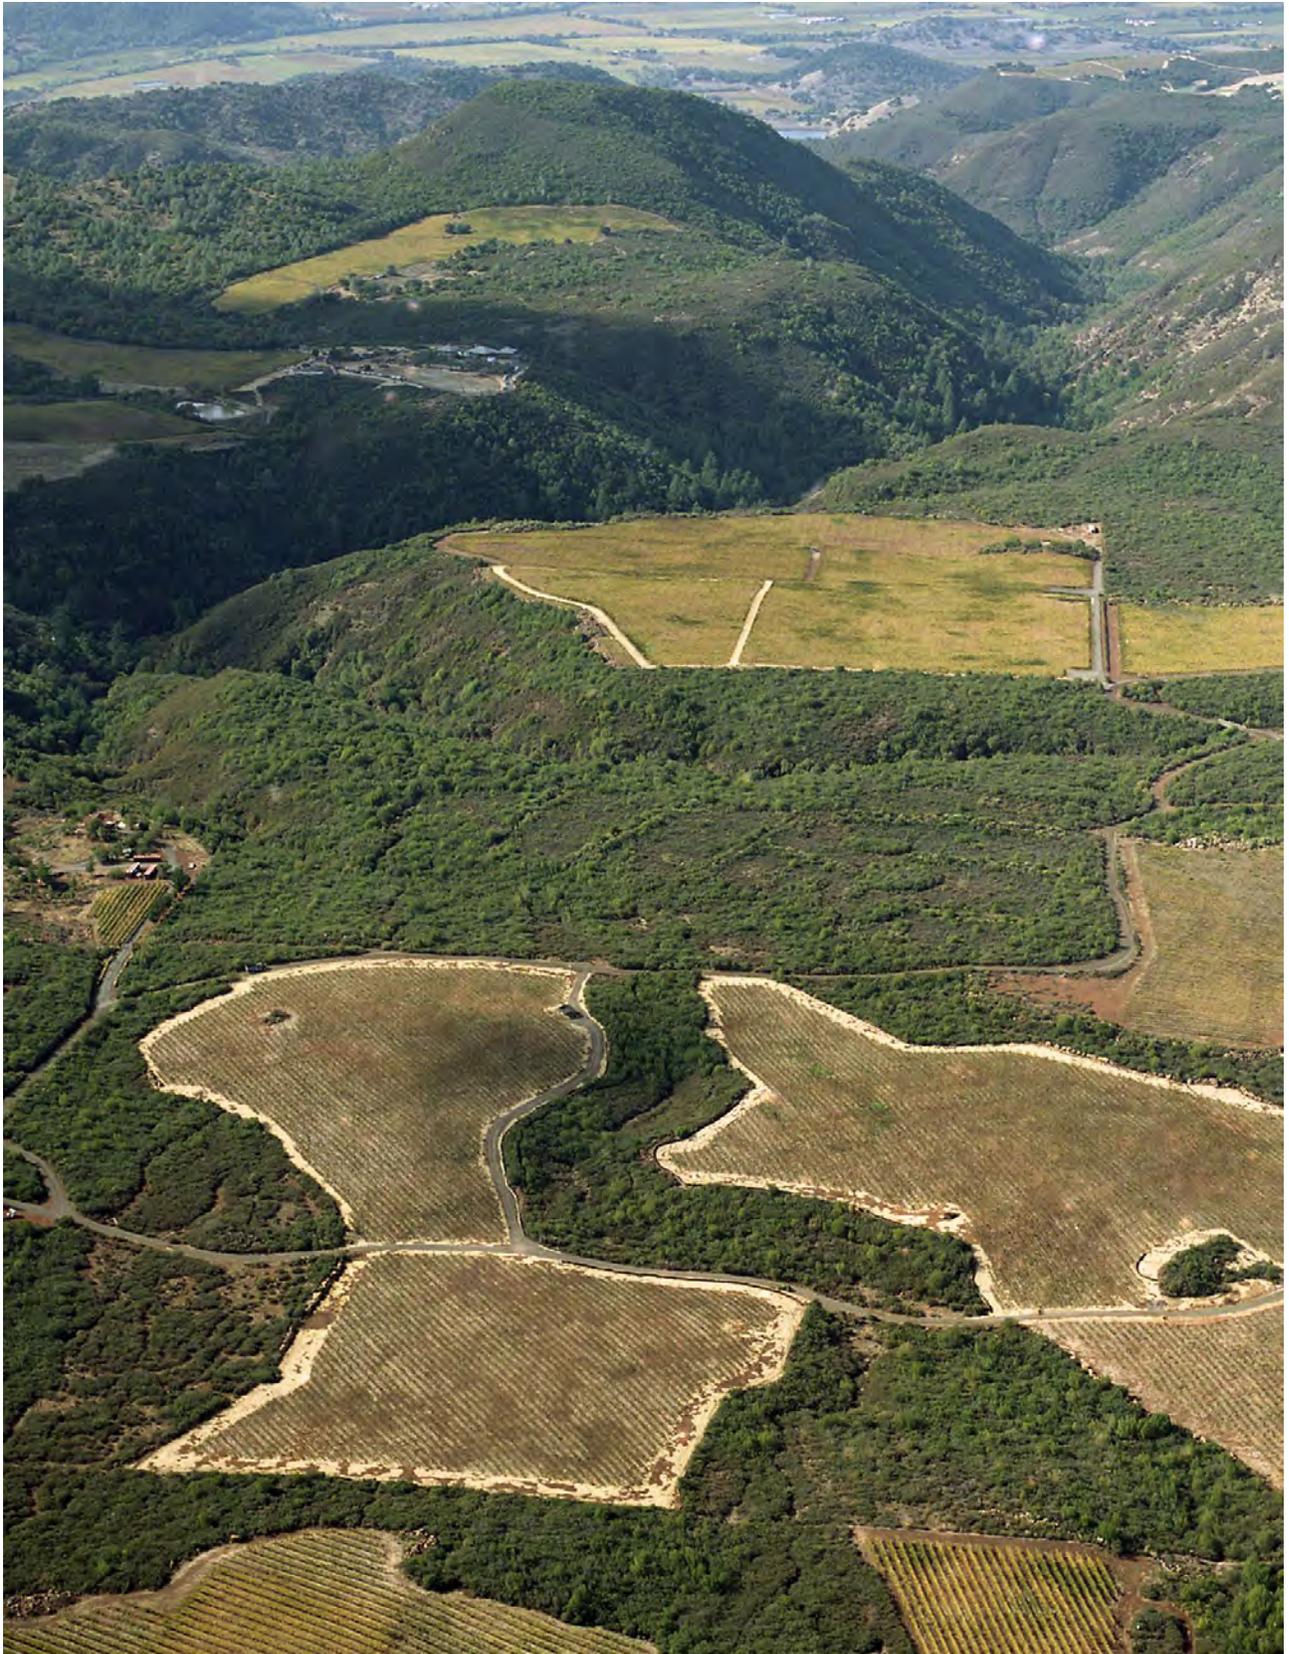
**Figure 7. California Vegetation Types (Obtained from Napa County Database. USFS, 1978)**

Soil type, soil moisture conditions, percent organic matter, solar aspect, slope, and climate are primary interacting factors supporting native plant communities in watershed areas still exhibiting natural conditions. Figure 7 mapped plant communities in the watershed in 1978 before the vineyard boom. Only a small area was mapped in 1978 as cropland. Since that time much more area in the upper mesa has been converted to cropland as is visible when comparing watershed air photos from 1993 and 2007 (figures 3 and 4) and in the 2002 air photo. The most common vegetation types in Rector Watershed were chaparral, manzanita, ceanothus, chamise, musk brush, chaparral pea, yerba santa, birch leaf mahogany - a variety of grasses and legumes, herbaceous plants, hardwood trees, and shrubs. Woodlands include small Live Oak, Blue Oak, California Bay Laurel, Buckeye. This group of hardwoods as well as assorted mixed conifers thrive in riparian corridors where moisture is more abundant. Leaf fall and litter from native plants exceeds generally exceed that of cropland vegetation. The photos that follow contrast vineyard cropland and roads that have displaced native chaparral, grasslands and woodlands.

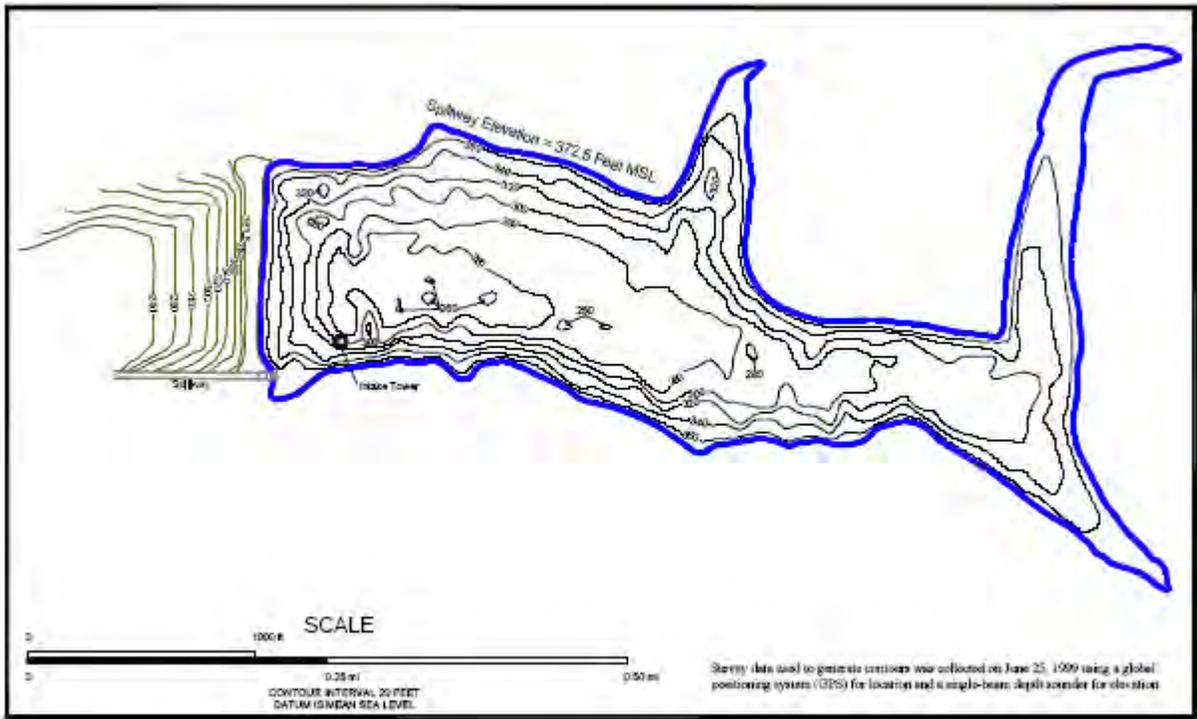
Figure 8. Bathymetric Map (Elevation Contour) of Rector Reservoir

Rector Reservoir is the primary source of water for the Veterans Home water system. The reservoir is located along the eastern side of the Napa Valley at the base of the Howell Mountain foothills near Silverado Trail, about 4 miles northeast of the Veterans Home. The reservoir was created by the construction of Rector Dam in 1945. The dam is an earthen structure approximately 152 feet high and 800 feet long. The lake had an original capacity of 4400 acre-feet. The capacity was increased in 1985 to approximately 4535 acre-feet (AF) by raising the spillway height by about two feet to its present elevation of 372.5 feet. The lake usually overflows over the spillway each year (Figures 8, 9, 10).

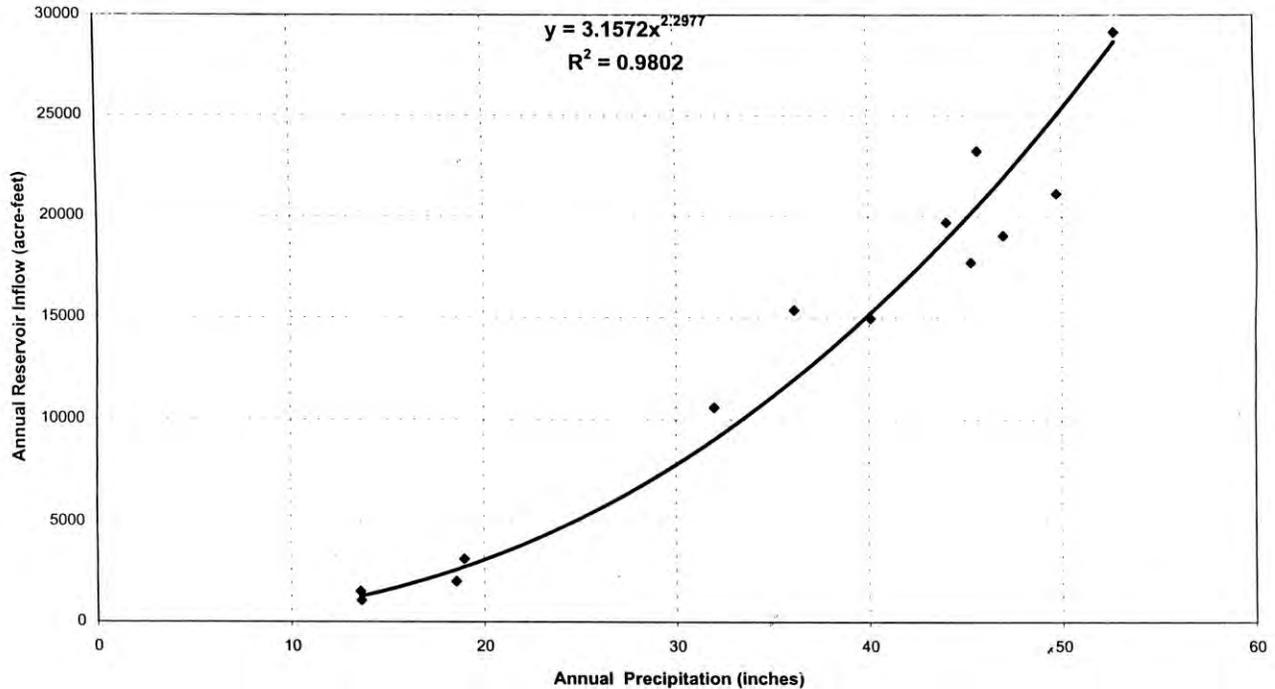
$y=3.1572 X^{2.2977}$  where y=inflow (acre-feet) and x=annual precipitation (inches) (DWR, 2000)

**Correlation Between  
Annual Reservoir Inflow and Annual Precipitation  
(1964 - 1978)**

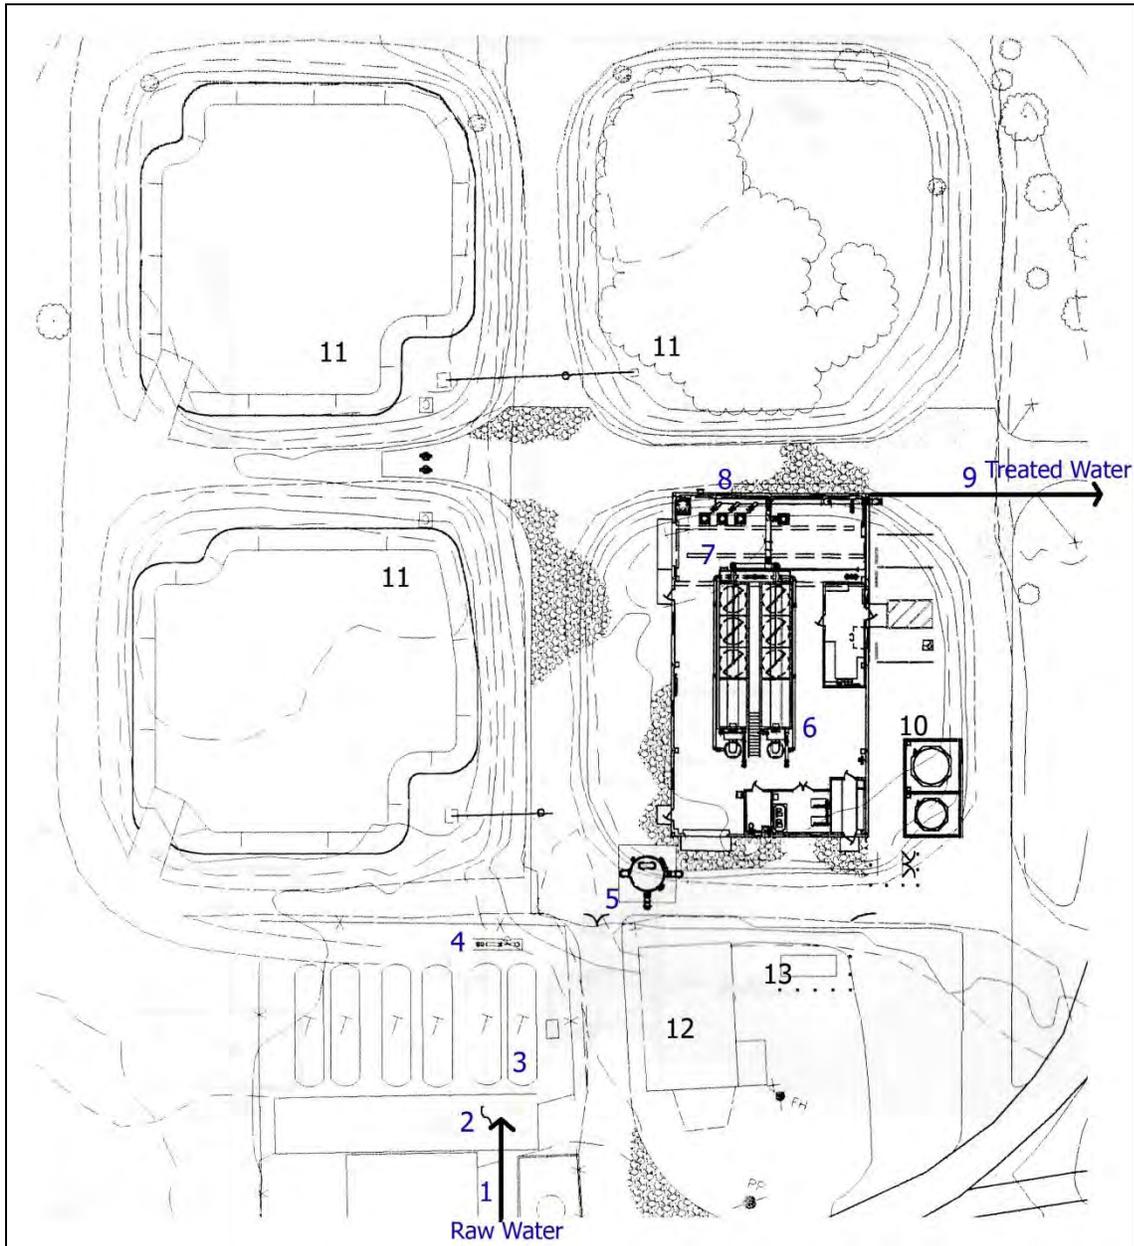
Figure 12. Map of Treatment Facility Shows the Flow of Water through the System

The conditioned water goes through the flocculation tank before entering the roughing filters. There are two roughing filters on one side of the flocculation tank and three on the other side. Each roughing filter has two cells and contains 72 inches of Torpedo Sand (1-mm effective size).

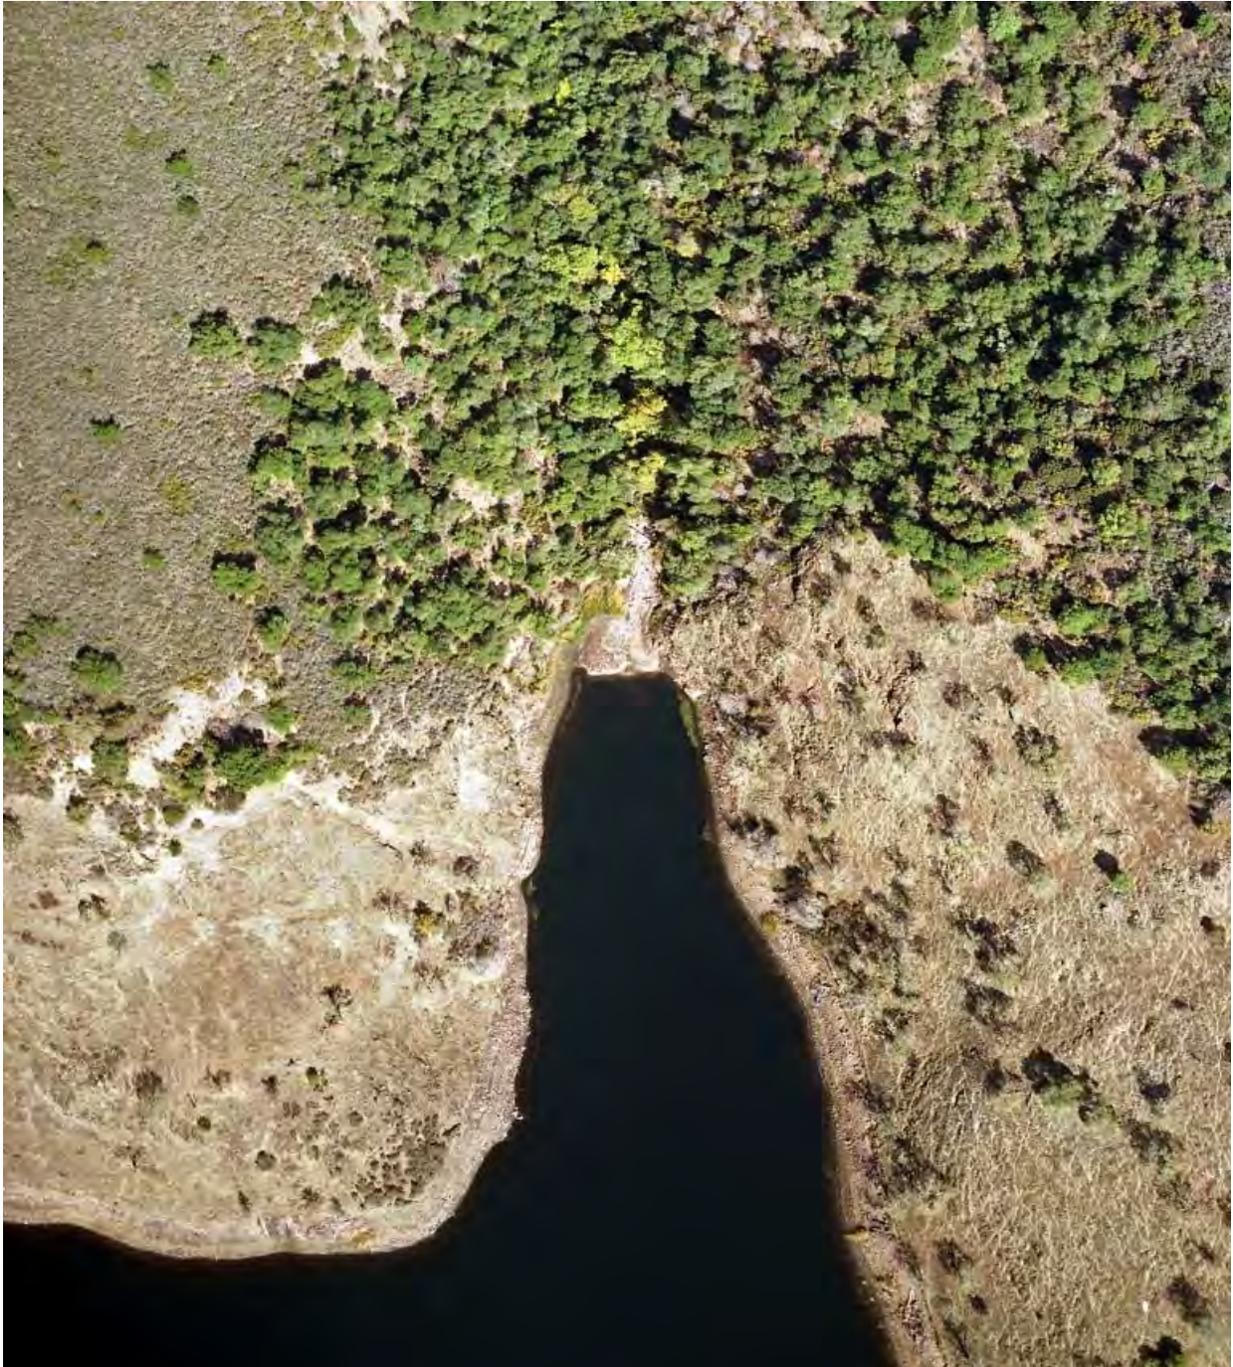
North Fork Delta (Trso Delta 3) sometimes termed Western Creek by treatment operators

Upon the site visit 7-23-08, the North Fork Delta (identified as Delta 3 by Trso) was composed of gravel and sand. The Delta ascended relatively quickly into a steep, bedrock channel. Above the alluvial deposit, the streambed climbs into a bedrock, step pool sequence with intermittent riffles. The stream has several nice pools that are at least 3 feet deep. The streambed is of bedrock, boulders, and cobble. The stream banks are well vegetated and stable. Coarse sand composed approximately 3% of the surface area of the channel. There were no evident deposits of any smaller fines in the stream or delta. In the previous 2003 Watershed Sanitary Survey, 3 miles of road were mapped.

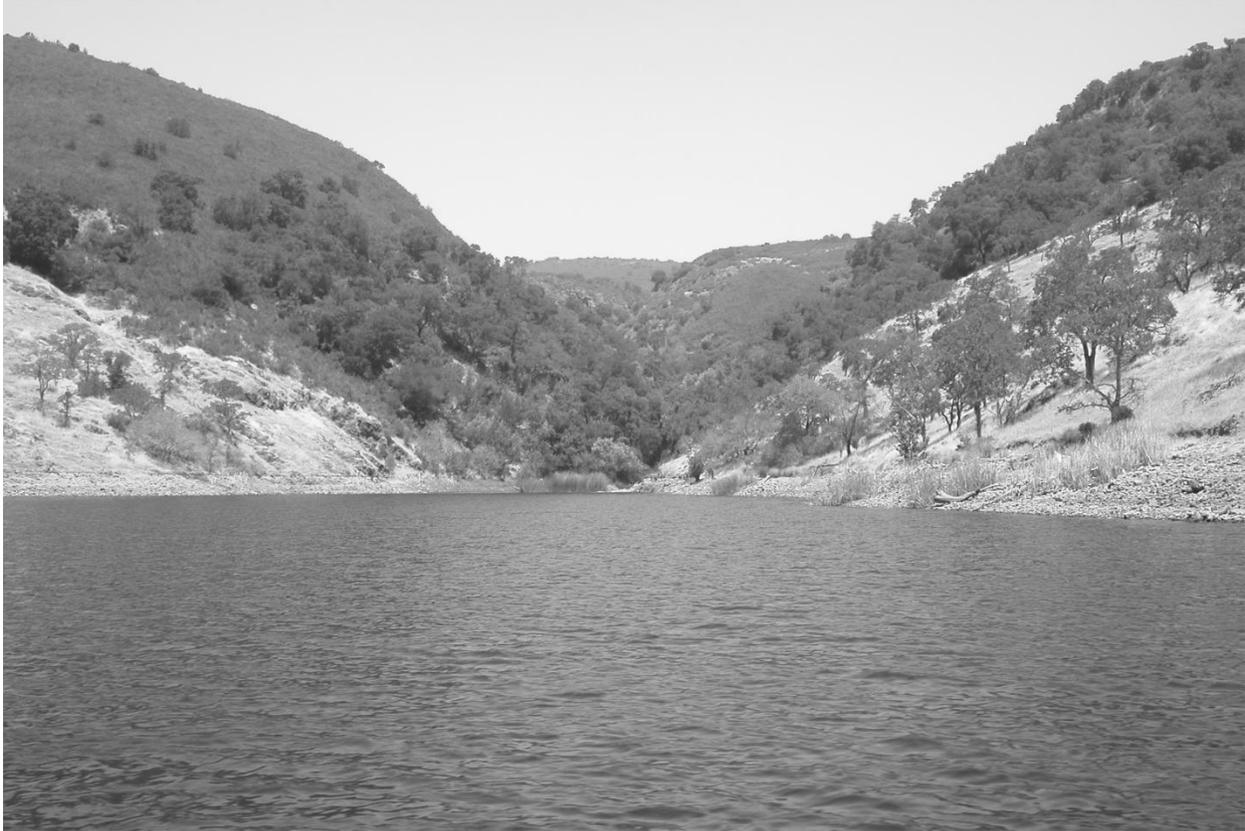
*North Fork Mouth as viewed from a boat*

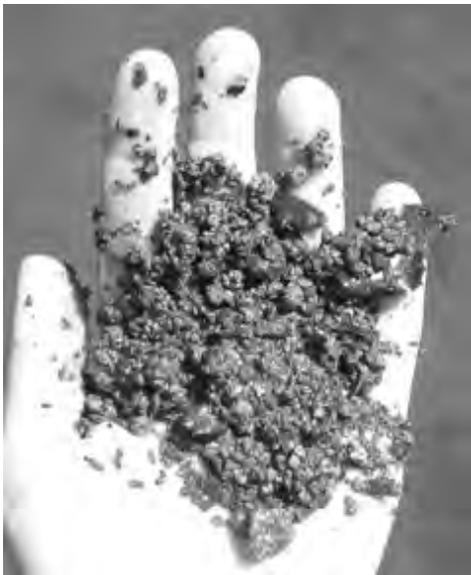
*north fork bedload (finest portion)*

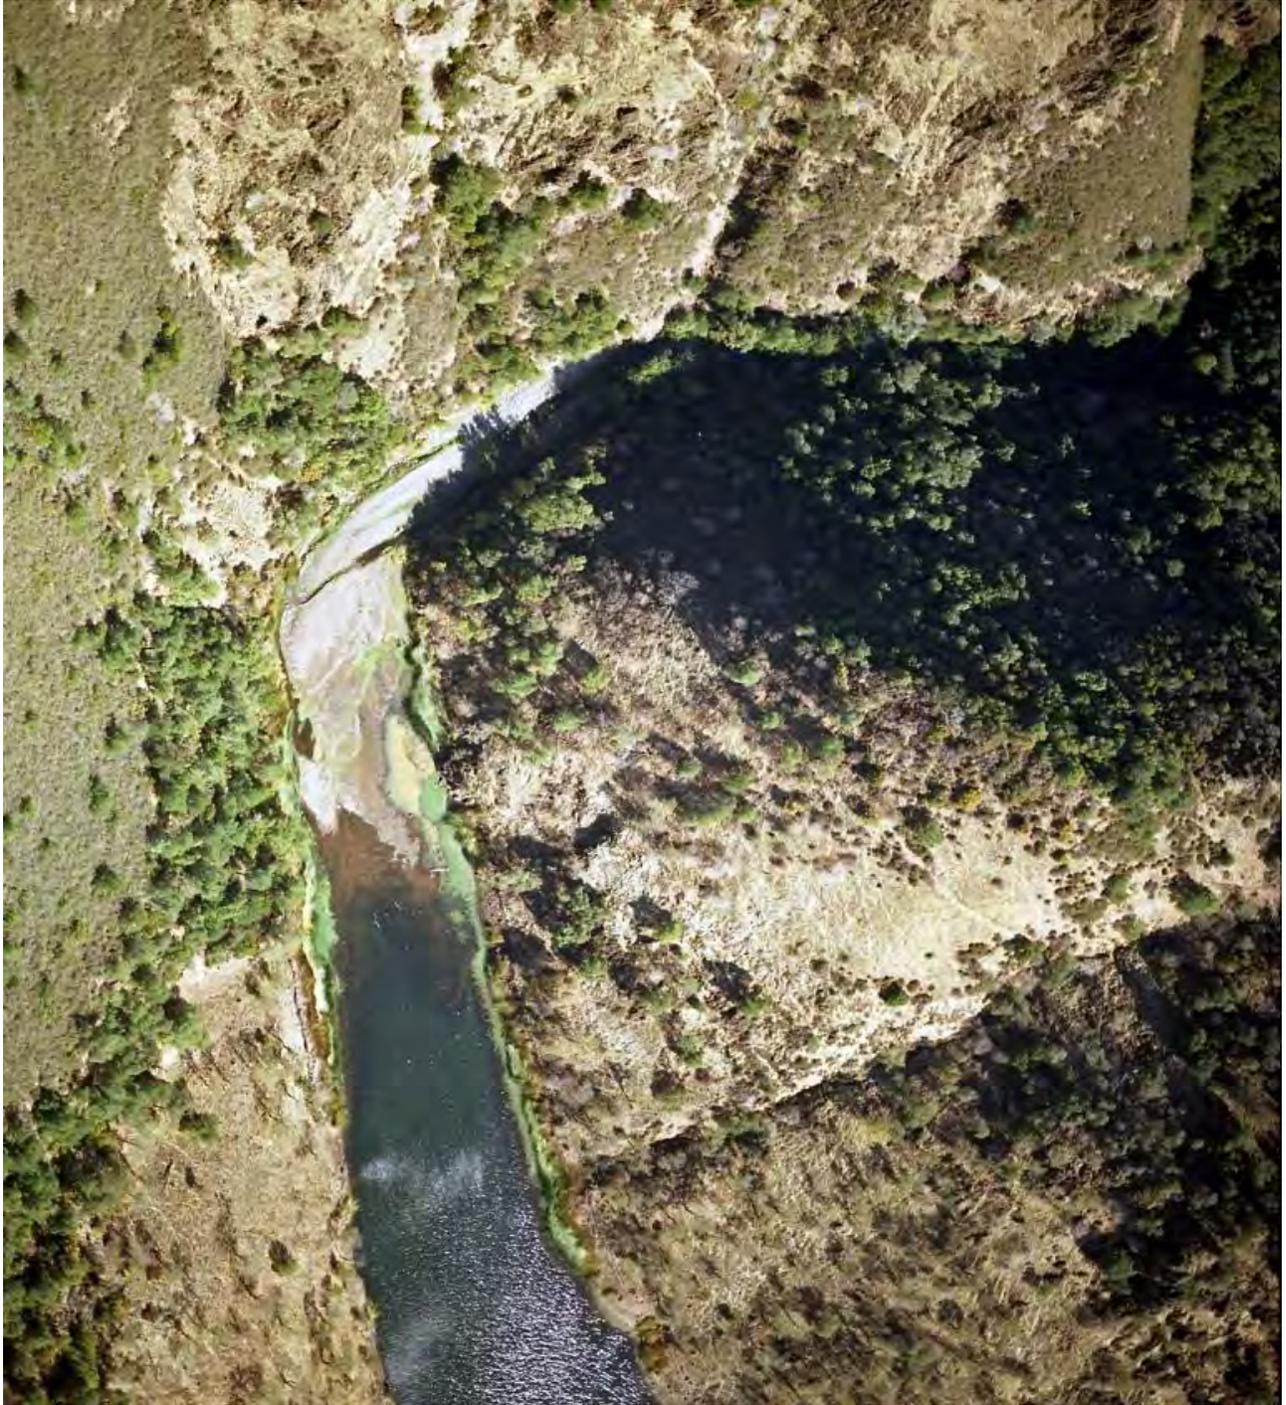
Mainstem delta: alluvial stored sediment partially visible under water, turbid water, algal mats

The mainstem Delta (identified as Delta 1 by Martin Trso) is the largest of the three deltae. Delta 1 was composed primarily of fine sand, with very little silt. Upstream, the delta was composed of gravel and cobble. The reservoir water and stream channel are both likely contributors to bank erosion along the west side of the delta/channel. This channel bed was composed mostly of large cobble and small gravel at the time of the site visit.

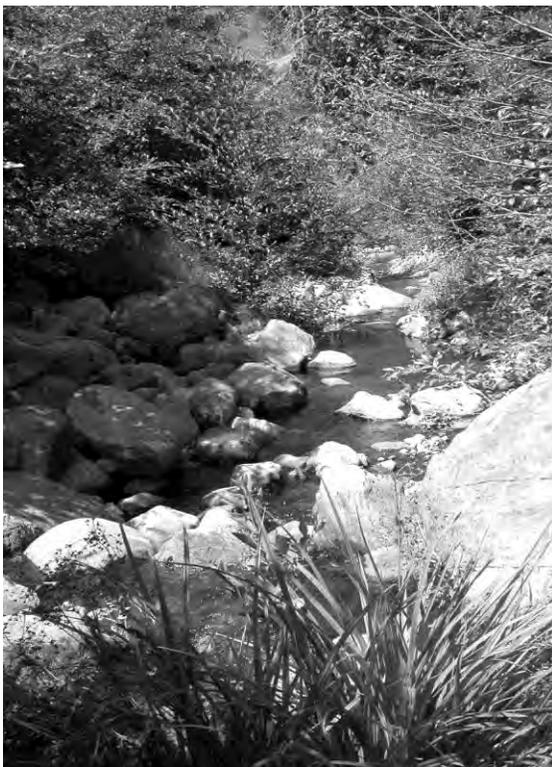
The channel bed of Rector Mainstem is composed primarily of gravel and cobble, with about 6% sand on the surface (a visual estimate by Ridge to River staff). This bedload is similar to that of North Fork (West Rector Creek) but grain sizes are smaller. Powdery silt was shaken out of dry sand, but there were no isolated silt deposits in the channel found during the site visit. There was a flowing primary channel and a dry secondary channel in the first 0.3 miles of the stream (the extent of the field survey). The channel banks were well vegetated. There were some large deposits of sand in the secondary channel.

Mainstem channel

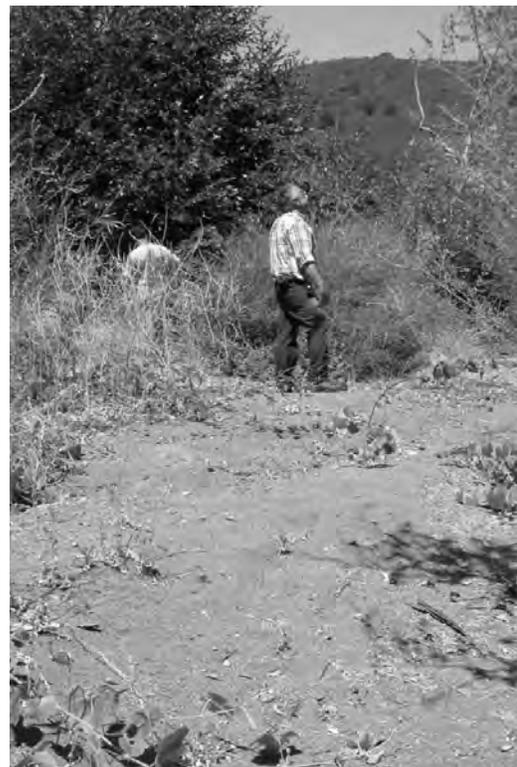
Mainstem alluvial bar at delta

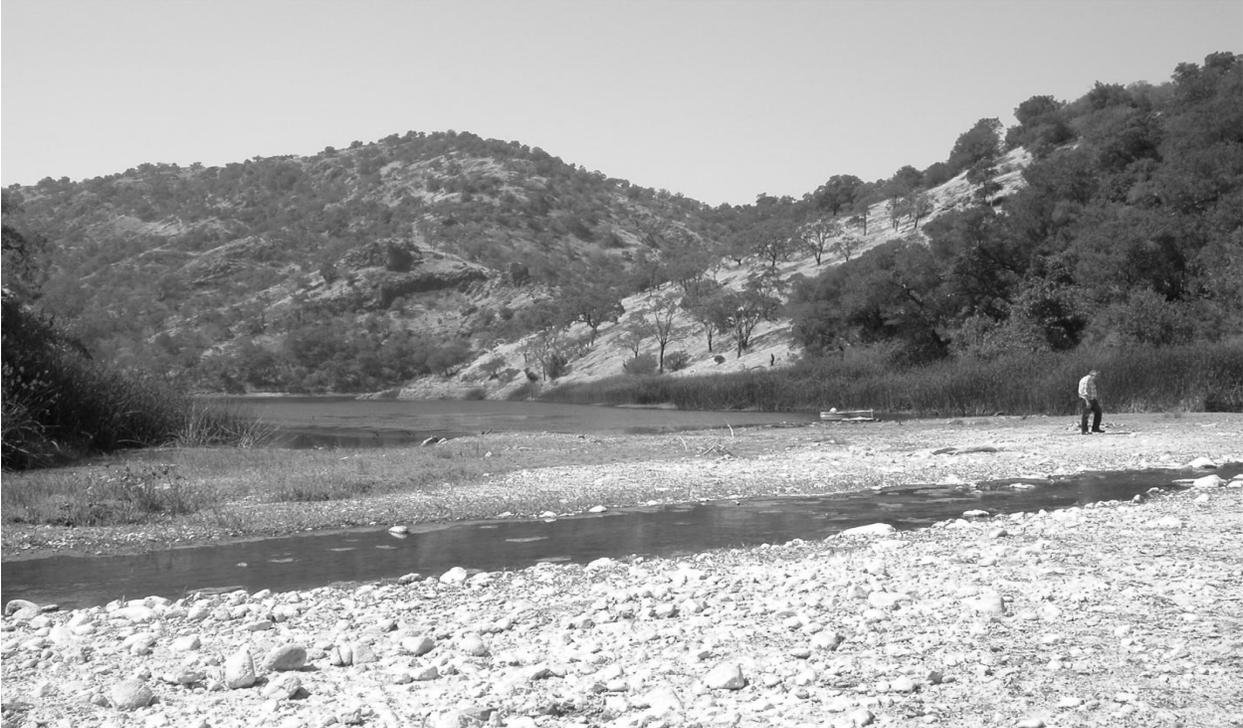
Mainstem delta looking into reservoir with boat and R. Van Voorhis in photo

Remnants of a weir was visible at the edge of the bed, however the structure was mostly covered in deposits. This weir was used in 1989 to measure inflow (Mark Nicander, personal communication, 2008).

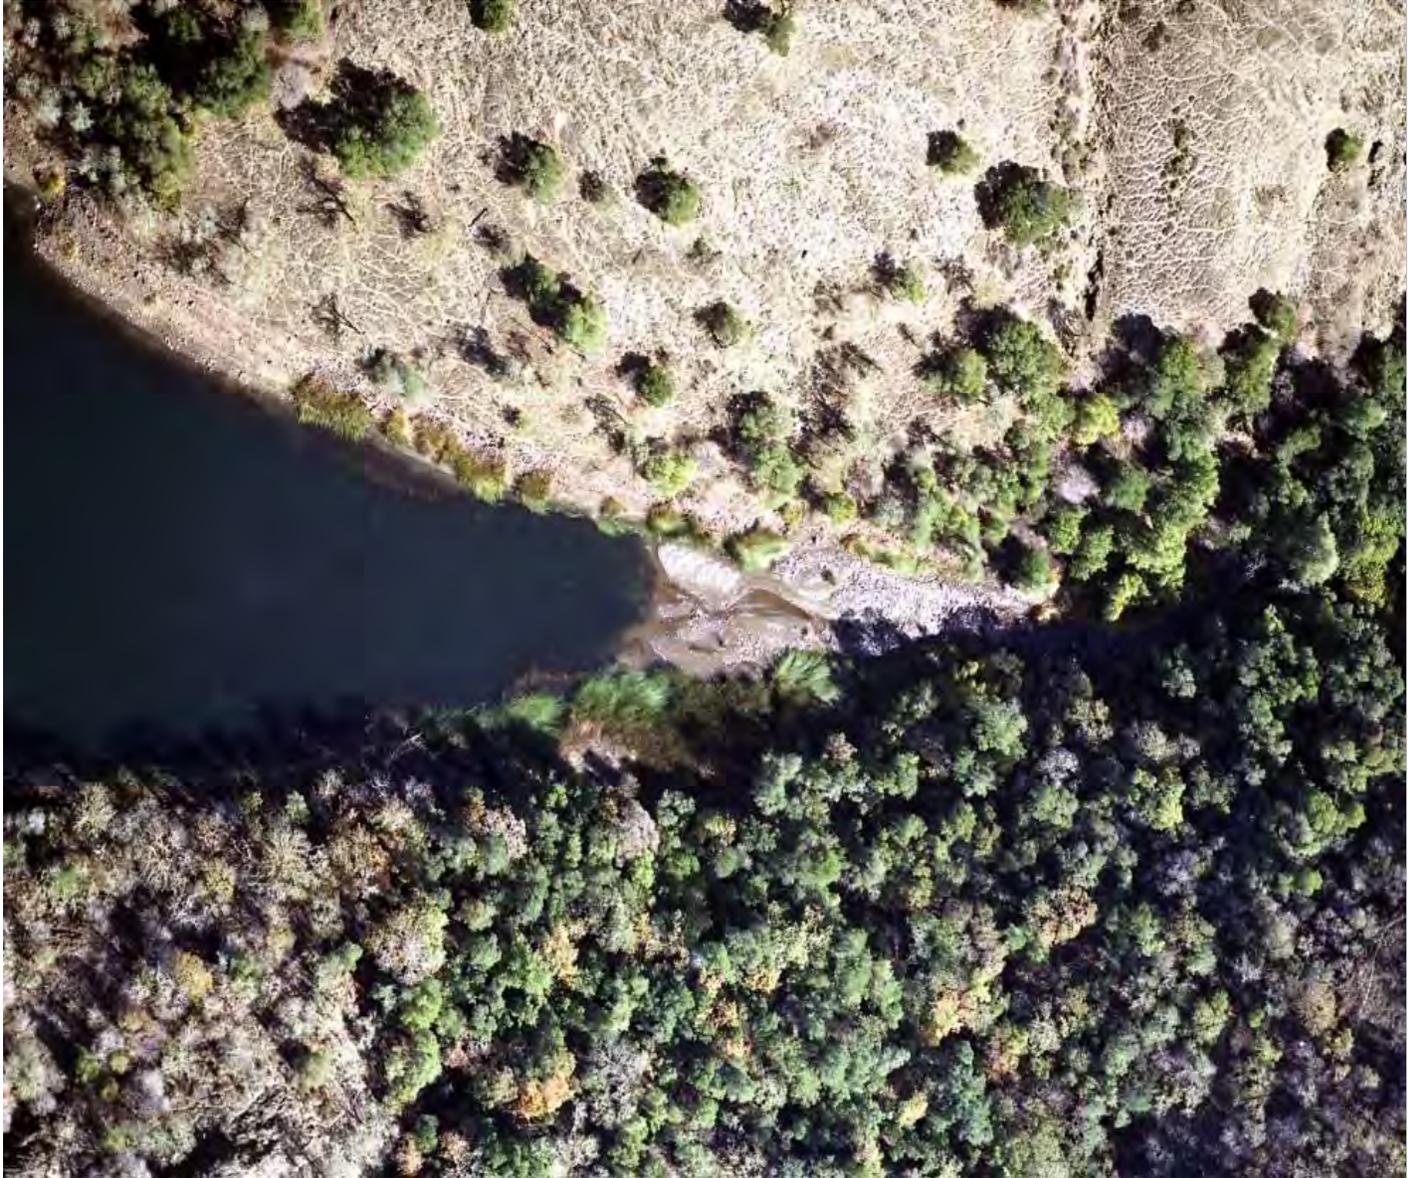
Lorette South Fork, Trso Delta 2: no obvious turbidity plume or algal mats

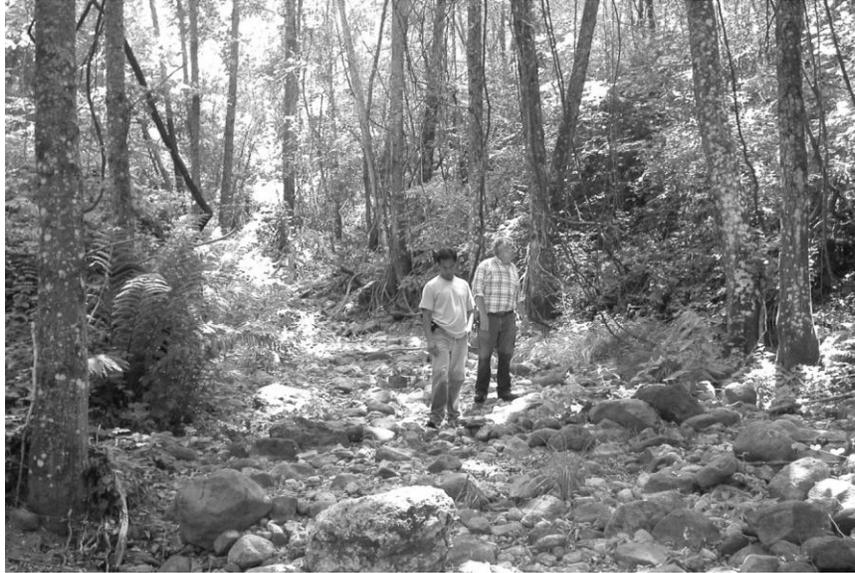
Lorette channel with Winniefredo Cruz and Russell Van Voorhis

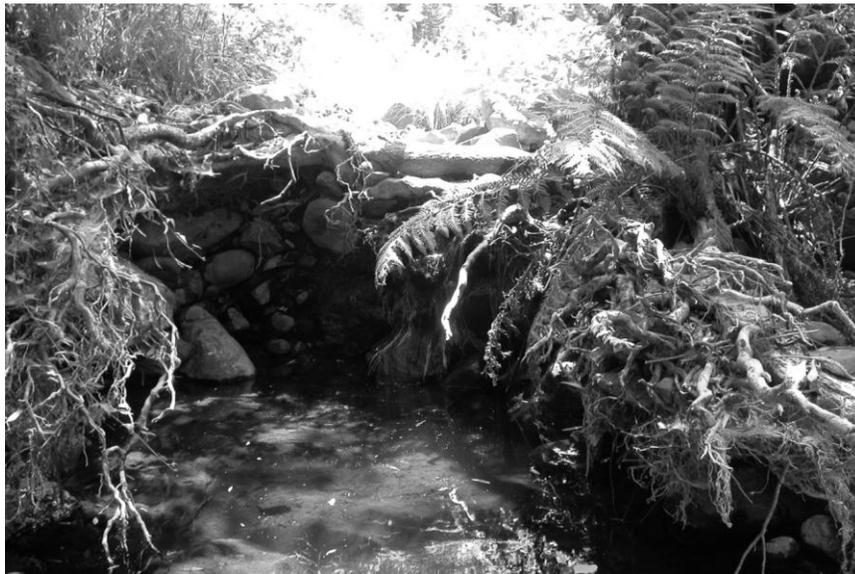
Lorette knick point head cut

Lorette Creek has a pool-riffle sequence through a channel bed of cobble and boulders with well-vegetated banks. Part of the channel bed was formed of silt. Bank erosion is visible in three places within the first quarter mile above the reservoir. There is a four-foot head cut in the channel, with bedrock channel above the headcut. Bank erosion seems to be relatively slow, as banks are held together by roots and rock. Bank erosion in this lower quarter mile may be a result of alluvial deposits that reduce the gradient of the stream and cause it to meander. Upper reaches appeared more stable. Lorette Creek is not as confined as the other two Rector forks. The hillslopes are vegetated completely down to the creek. The channel has a little room to meander and erode, pushed over by mid-channel trees, rocks, and root wads. Although a small part of the streambed is formed of silt, there are no silt deposits within the channel. Sand deposits (mostly in the secondary channel) did not form more than 5% of the surface, while silt and sand combined formed approximately 10% in the lower section (less upstream). The Lorette channel appears to be the least stable of the three creeks visited.

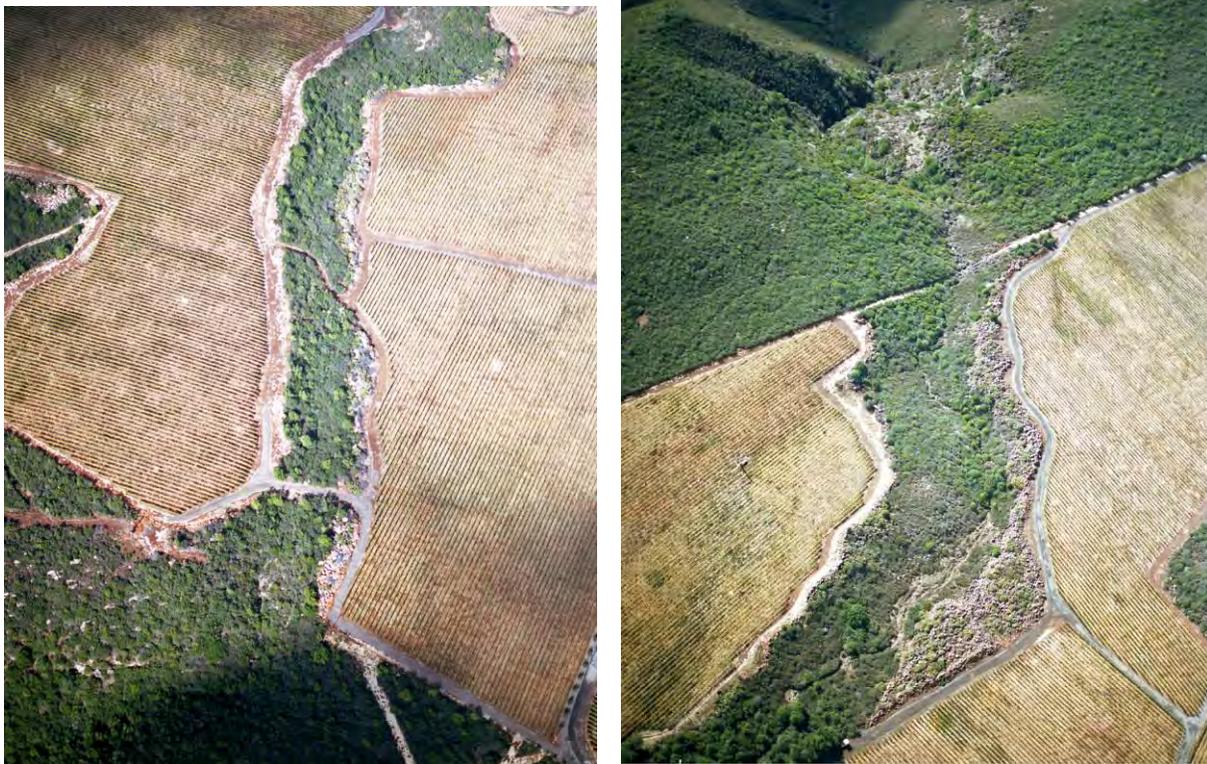
Riparian corridor protection zones some with rock “berms, vineyard roads, vineyard rows

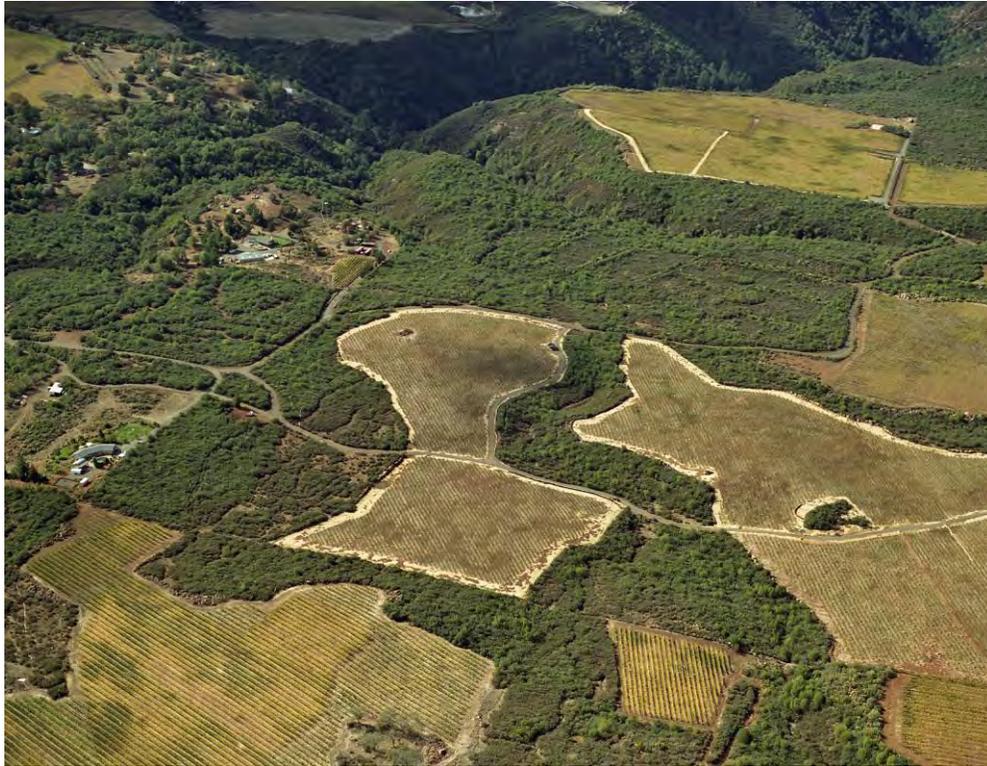
*Gazing across the upper mesa into Mainstem Rector Canyon at native chapparral and vineyard vegetation*

The season that vegetation coverage is measured is important because some vegetation goes dormant during part of the year and because erosion is primarily caused by process associated with the rainy winters. Other species are dormant in the summer. As vineyard laborers walk through the rows to tend the fields and harvest grapes, dry stems of summer cover-crops will be trampled. As these stalks are degraded, foot traffic will dislodge soil particles. Plant growth will likely remain dormant until the first few winter rains provide enough moisture for growth. Soils are especially vulnerable to surface erosion in the beginning of winter in a first flush (Barber, 1998) when cover crops are likely at their minimum coverage and soil particles have likely been mechanically dislodged by foot traffic. It is important to measure percent coverage at different times throughout the years to fully understand the surface erosion potential under all conditions.

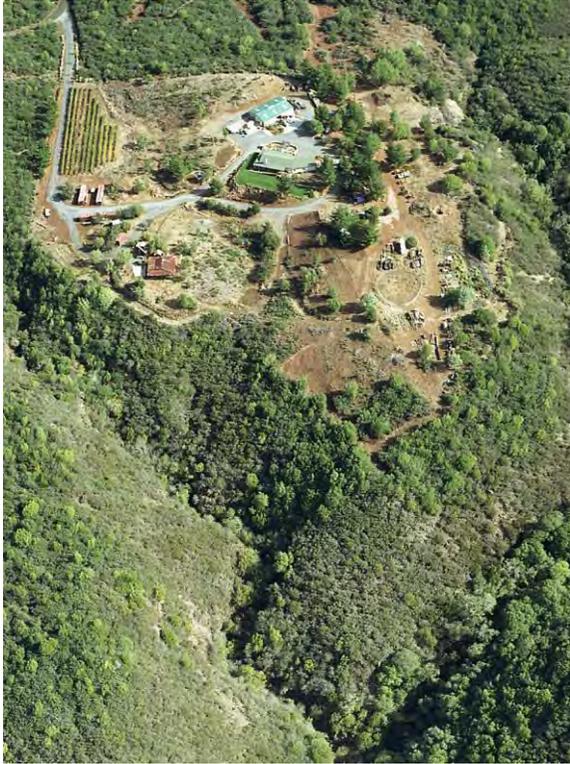
*Bare slopes around the nose of a ridge*

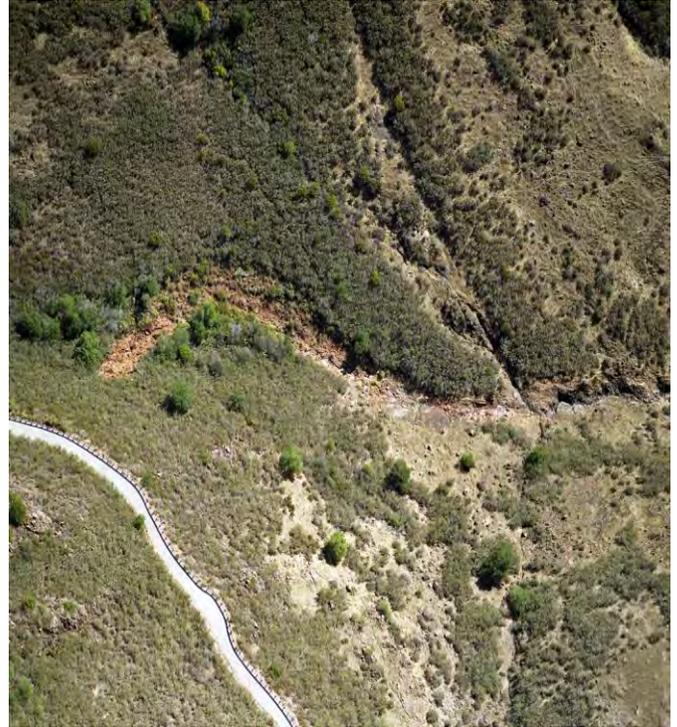
*Concrete road's stream diversion relieves yielding debris torrent scar*

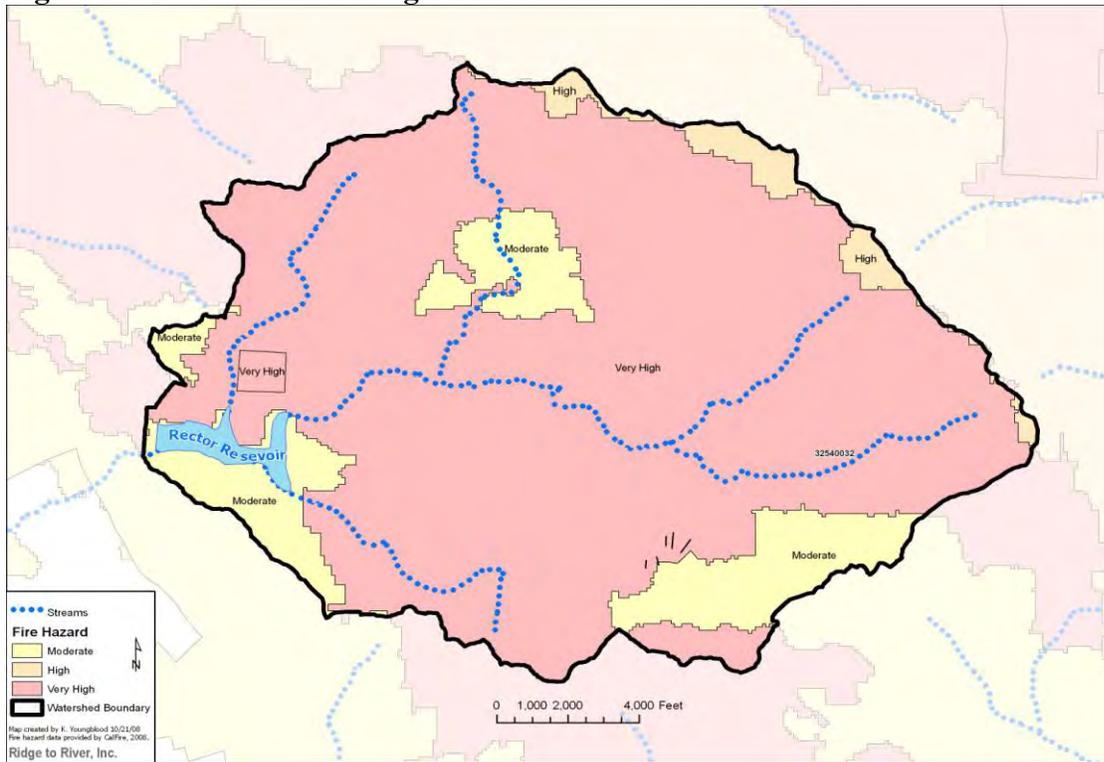
Figure 16. Fire Hazard Rating at Rector Creek Watershed

The fire hazard for most of the area within Rector Watershed is considered very high (Figure 16). Small portions within the watershed are considered to be at high risk or moderate risk. The last major fire that swept through the Rector Watershed was on June 22, 1981 (Figure 17). In 7 hours, the Atlas Peak Fire consumed 23,000 acres of brush, grass and timber and destroyed 61 homes, 91 other buildings, 40 vehicles and numerous wildlife and domestic animals. The fire front was up to seven miles across and moved at 4,500 feet per hour. The fire was started by seven arson set fires. Rumor has it that the fire was spread, at least partially, by a grey fox racing by with its tail afire (*Mark Nicander -2003, personal communication*). The conditions that day were 103 °F temperature, 18 mph winds, and humidity less than 4%. The fire consumed vegetation across the entire Rector Watershed and other areas as well (*NCPD, 2003*). The ash from the fire contaminated Rector Reservoir for several years during which Veterans Home purchased all their water from the City of Napa's intertie. The natural fire return interval in unsuppressed areas of this vegetation type and climate range from 10-40 years. Four other fires burned part of the Rector Watershed within the 22 years previous to the all consuming Atlas Peak Fire. One of these fires was only 12 years prior to the Atlas Peak Fire. Twenty-seven years have passed since the Atlas Peak Fire, so another can be expected at any time.
