# Rector Creek Reservoir Watershed Sanitary Survey 2009 Update

July 10, 2009

Ridge to River Incorporated Environmental Services

Veterans Home of California and Rector Reservoir Surface Water Treatment Facility

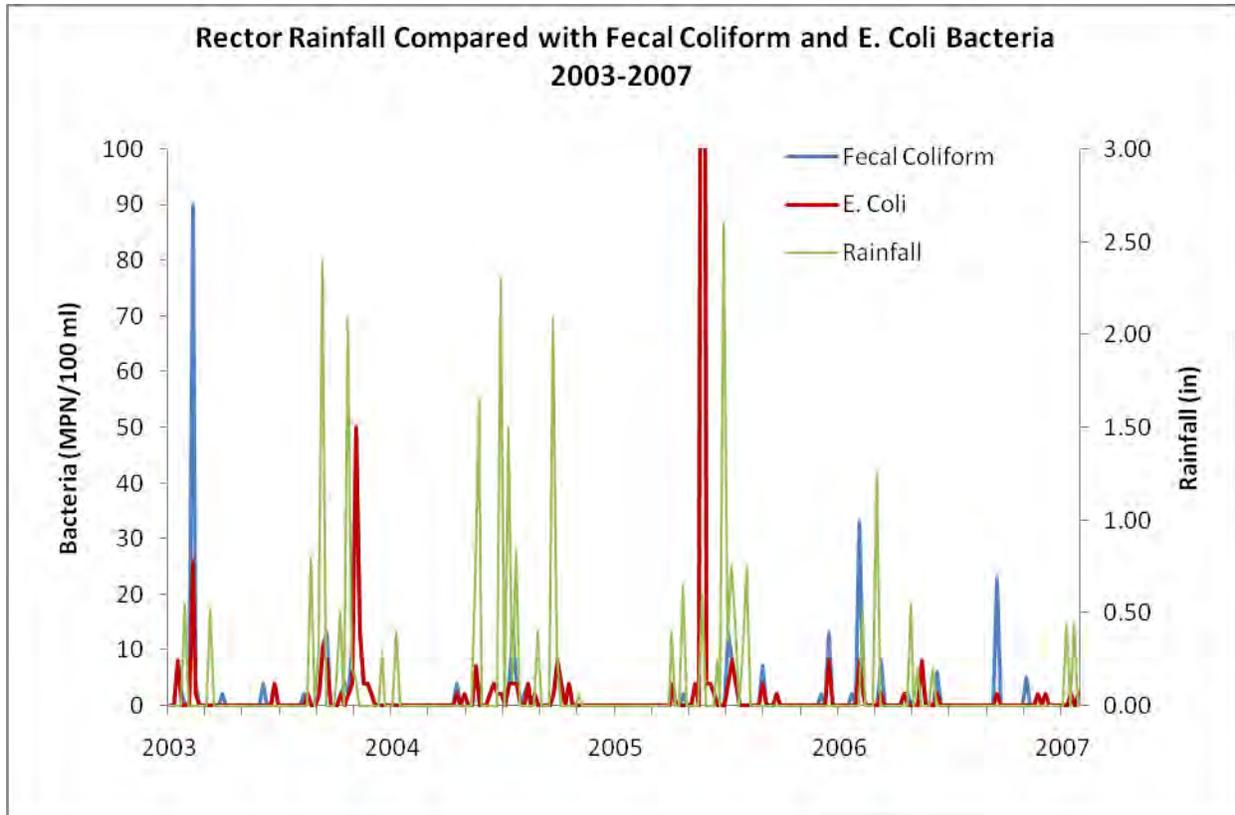
**Figure 19. Rector Rainfall Compared with Fecal Coliform and *E. coli* Bacteria 2003-2007**

Total coliform, fecal coliform, and *E. (escherichia) coli* are monitored weekly in Rector Reservoir. Coliform rises in response to intense rainfall that rinses them into raw source waters, as may be inferred when comparing the rainfall and coliform charts. Testing is done for these bacteria in order to determine possible contamination from human, bird, or other mammalian fecal waste. Coliform bacteria, including fecal coliform, *E. coli*, are naturally occurring in the large intestines of warm blooded mammals and birds. *Escherichia coli* (named after Theodor Escherich who isolated the type
